WATER PUMPS REPAIRED AT HISTORIC RESERVOIR

Queen Mary Reservoir, Surrey

Damaged pump volutes, totalling a surface area of 282m².

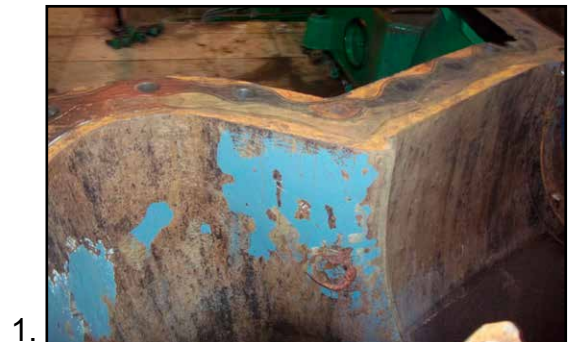
After years of frequent use, certain areas of the pumping equipment were suffering from cavitation damage, which in turn was seriously hindering the efficiency of the pumping system.

1. Pump casing prior to removal of existing coating
2. Pump casing severely corroded
3. Sponge blasting in progress
4. Completed application

Application carried out in accordance with a modified version of Belzona Know-How System Leaflet CEP-3. Firstly, Sponge Blasting equipment was used on the upper and lower casings to remove the previous coating and create a cleanliness of at least SA 2 ½ and produce a surface profile of no less than 75µm. Due to the extent of the damage, (some areas of each volute exhibited up to 50% corrosion) complete metal repairs were prescribed using Belzona 1111 followed by a protective coating of Belzona 1341.
