LEAK-FREE SKYLIGHTS WITH BELZONA!

Missouri, USA

June, 2013

Poorly engineered rooftop skylight(s) leaking into the main hallway and traditional roof repairs failed.

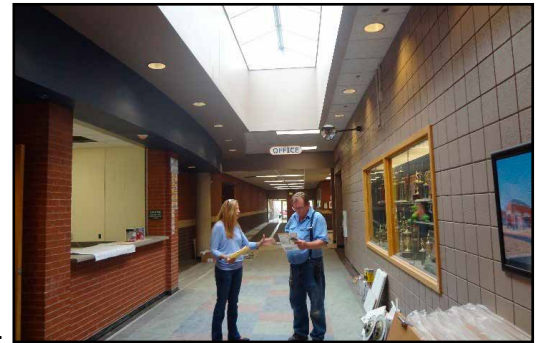
1. Consultant and School Official discussing the project in the main hallway directly below the leaking skylight.
2. Picture of a leaking skylight
3. Application of conditioner prior to meshing the seams
4. Completed repair with Belzona 3111 applied to the seams, flashing and glazing

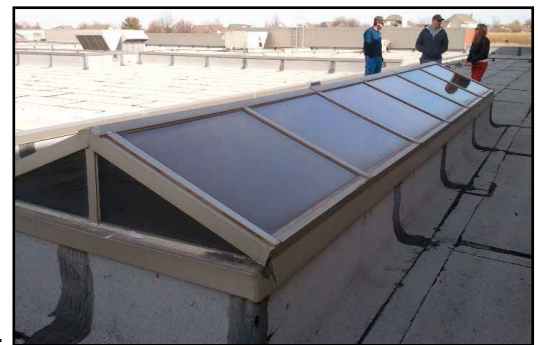
2.

The skylights in several different schools were leaking into the faculty and student areas below. Periodic temporary measures, such as caulking and mastics had been tried without solving this constant maintenance issue.
