BELZONA REPAIRS CONCRETE RAMP

Cracking on an important loading ramp

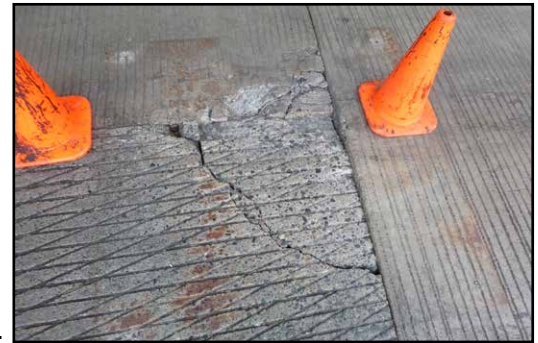
The foundation under the loading ramp had been undermined causing one concrete panel to crack which made a bump in the road for forklifts, which would then lose loads when hitting this joint.

1. Area on forklift ramp for repair
2. Teflon spacer fit into joint to separate adjacent panels
3. Conditioner (seen around edge) and 4111 applied to repair area
4. The ramp repaired from a distance
