BELZONA STOPS CLARIFIER LEAK EXTERNALLY

Leak at clarifier wall

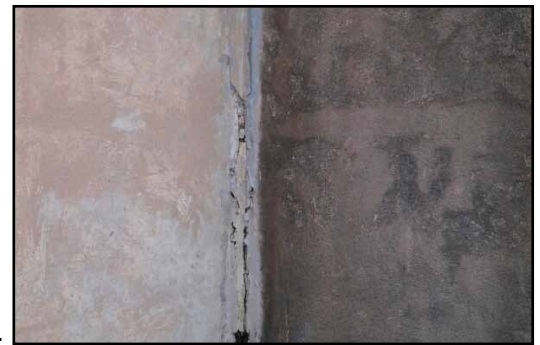
1. The application area before repair
2. The application area before the area
3. The area after the application and leak free
