BELZONA REPAIRS AND PROTECTS GAS TREATER

Heavy Gas treatment vessels in a refinery

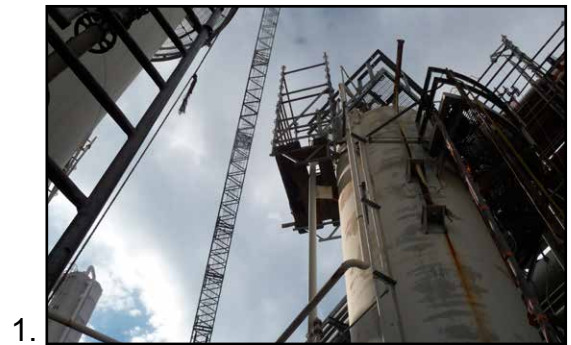
1. Vessel exterior
2. Vessel floor and wall
3. Close up of pitting
4. Finished project

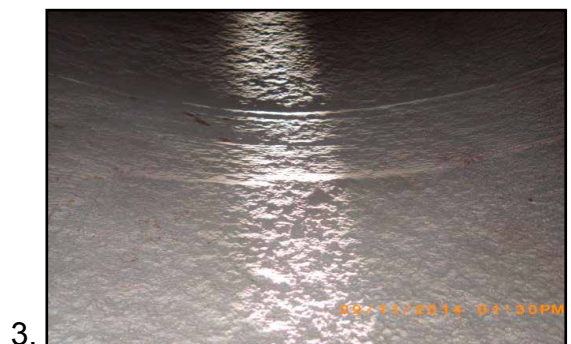
Corrosive process environment used in treating Heavy Gas and Natural Gas caused excessive pitting to vessel walls. Not only did coating have to stand up to this environment it needed to withstand steam out approaching 400 °F.

Application was carried out in accordance with a specific Method Statement developed for this project which included Belzona Know-How System Leaflet TCC-3 for repairing/renewing damaged linings. Belzona 1111 was used for pit filling; Belzona 5892 was applied using a brush as a two coat system in accordance with Belzona Instructions For Use.
