CORRODED PIPE REPAIRED WITH BELZONA!

Petrochemical Plant, SE Texas, USA

12-inch diameter Natural Gas line that supplies the entire complex of 3 separate plants.

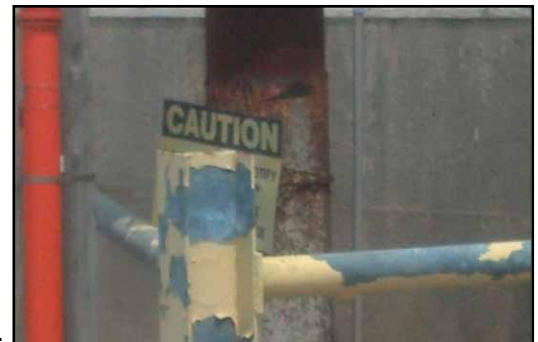
Poor protection on the flange caused corrosion to the pipe and flange.

1. Before the application
2. Sponge blasted and prepared with Belzona 5831
3. Belzona 1111 applied to all pits and gaps between nuts/bolts
4. Belzona 5111 applied for corrosion and UV protection
