SLIPPERY FLOOR DRAIN GETS BELZONA GRIP!

The Customer needed a safety grip system for a slippery floor drain area in fish processing plant to avoid falls & injury

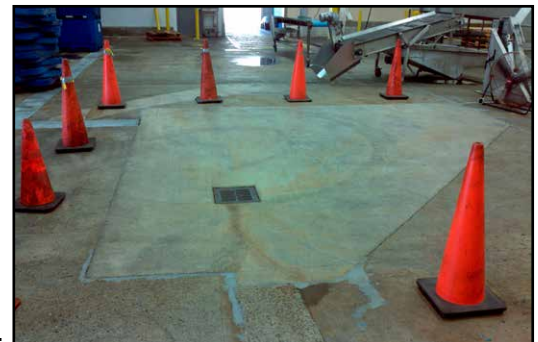
Concrete floor area around drain is very slippery with water & fish entrails. Area sees both forklift and pedestrian traffic

1. Floor drain before the application
2. Thorough cleaning
3. Non-slip application of the floor drain is now complete
