## BELZONA PROTECTS ASH SLURRY TANK

Ash slurry tank

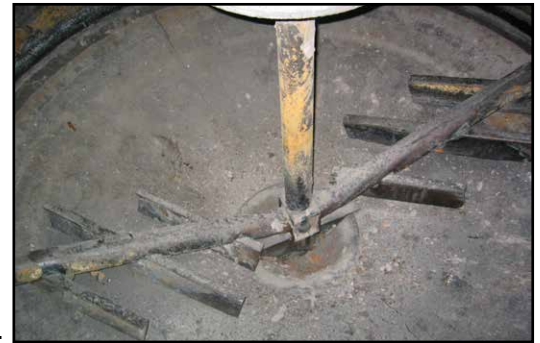
Customer looking for a proven coating to protect the life of their ash slurry tank. The tank receives solids in slurry at elevated temperatures from plant incinerator. Abrasion is noted problem with this component

1. Ash slurry tank before coating
2. Ash slurry tank during second coat application
3. Ash slurry tank after coating
4. Two years after above application
