BELZONA REPAIRS TIRE'S SIDEWALL

Repair of the sidewall of a front loader and a large dump truck.

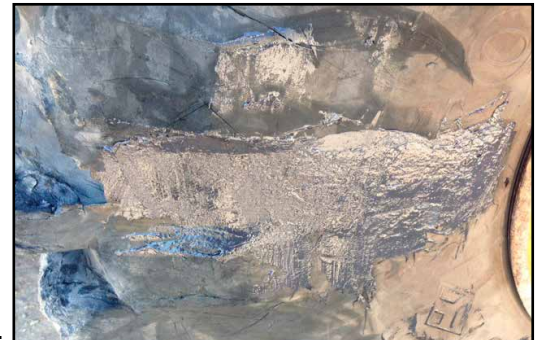
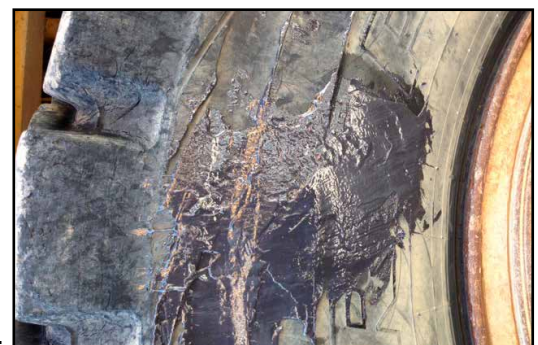
1. Completed application
2. Completed application

A tire of a front loader and a tire of a large dump truck had a cut in the sidewall rubber and a small chunk taken out of the sidewall, respectively. The tires would need to be replaced if there was no other alternative. They could remove the tire to be vulcanized, but that repair is costly and could take several days of downtime.

The surface area around the damage was prepared and roughened. The substrate was then conditioned with Belzona 2911. Once the conditioner dried, one coat of Belzona 2311 was applied around the damaged area. Then, Belzona 9341 was stippled before another coat of Belzona 2311 was applied.

The tire repair was easy and allowed a quick return to service, saving time and money. The cost savings was about \$10,000 per tire, which is the cost of replacement. Additionally, the downtime was only a couple of hours as opposed to days. The tires have been in heavy use for about a month and are holding up well.
