BELZONA REPAIRS A DOCK HOSE BEFORE INSPECTION

Terminal Dock, Louisiana, USA

Rubber Dock Hose with cuts.

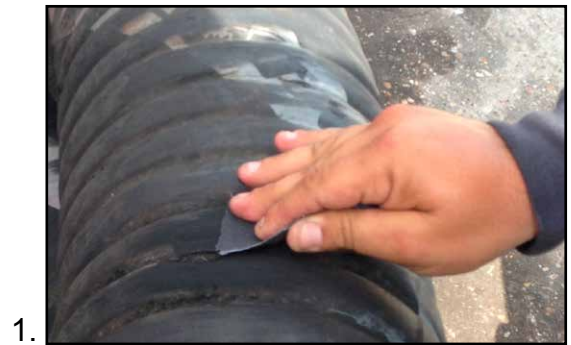
1. Area being prepared for repair.
2. Area after Belzona 2911 applied.
3. Belzona 2311 applied.
4. Finished repair before tape removed.

After proper surface preparation, the application was carried out in accordance with a modified version of Belzona Know-How System Leaflet SOS-12.
