## BELZONA REPAIRS A CONVEYOR BELT

Conveyor belt with a piece missing.

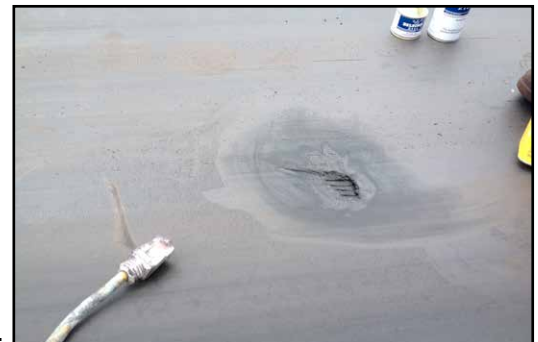
Conveyor belt had a 2" x 2" piece of rubber missing.

1. The area prepared for repair
2. Application is complete

The application was carried out in accordance with Belzona Know-How System Leaflet SHM-1. The hole in the belt was filled with Belzona 2311.
