FORMING FLAT FLANGE FACES ON A VENTURI WITH BELZONA

Flanges on a large venturi

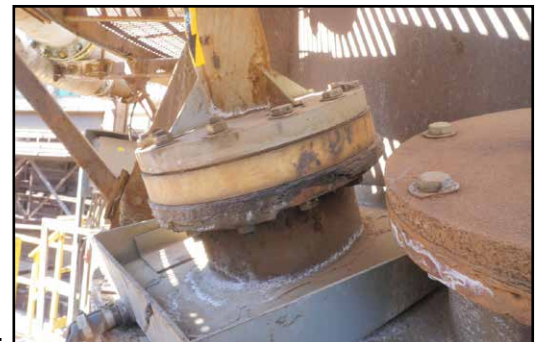
1. Flange on neighbouring unit in service; one year after rebuild, there is zero leakage in any of the 10 repaired flanges. Note the catch basin under the flange; the Belzona repair has made these redundant and they are being removed. Original trial flange is still in excellent condition after two years in service.
2. Forming plate clamped in place, with plastic pipe used to form bolt holes.
3. Perfectly flat rebuilt surface seats the gasket properly and does not leak.

Belzona 2111 is applied to the prepared and conditioned surface; Belzona 2121 is applied to a flat metal forming plate (already coated with Belzona 9411), and this plate is clamped into position with plugs inserted into bolt holes. When the plate is later removed, a perfectly flat gasket surface remains. The application was carried out in accordance with Belzona Know-How System Leaflet GSS-1.
