## BELZONA QUICKLY REPAIRS CONVEYOR BELT

Conveyor belt.

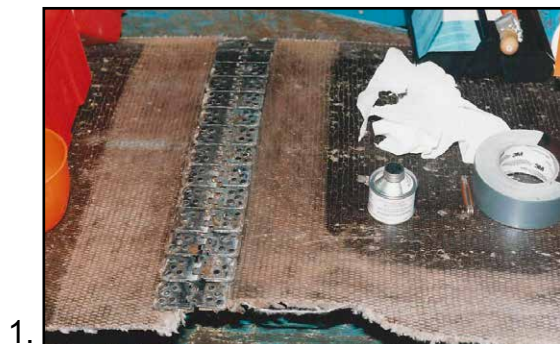
One of the joining clips came apart, hooked on the structure and tore away a piece of the belt. If it was left alone, it was likely to continue tearing.

1. Conveyor belt with area roughened
2. Bond breaker over the clips to allow movement and conditioner on the belt
3. Applying Belzona 2311 over the damaged area
4. Finished conveyor and ready for service

The belt was roughened and Belzona 2911 was applied and allowed to cure. A bond breaker was taped over the joint clips to allow movement. Belzona 2311 was mixed and applied with Belzona 9341 to coat the joint and seal the damaged area. The application was carried out in accordance with Belzona Know-How System Leaflet SHM-4.
