BELZONA RESTORES ELECTROLYTE PUMP BASES & CONTAINMENT AREA

Copper Mine, Arizona

2013

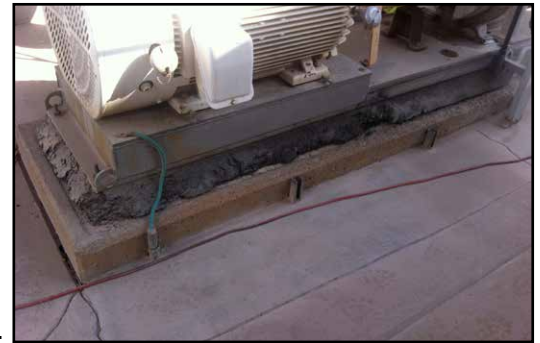
Leaking copper sulphate/electrolyte with 20 % sulphuric acid, has caused damages to the pump bases and containment area.

Deterioration due to chemical attack has jeopardized production of copper. Vibration in the pumps as well as ongoing spalling and acid attack require Belzona products.

1. Damages to pump base caused by sulphuric acid attack
2. Damages to pump base repaired with Belzona 4131
3. Completed repairs to 3 pump bases & containment area
4. Final application of Belzona 4311 to prevent future chemical attack
