## PICKLE TANK REPAIRED USING BELZONA PLATE BONDING

Automotive Parts Manufacturer, South Wales, UK

Pickle tank containing 36% Hydrochloric acid, used in the process of decontaminating manufactured car parts through a system of wash baths.

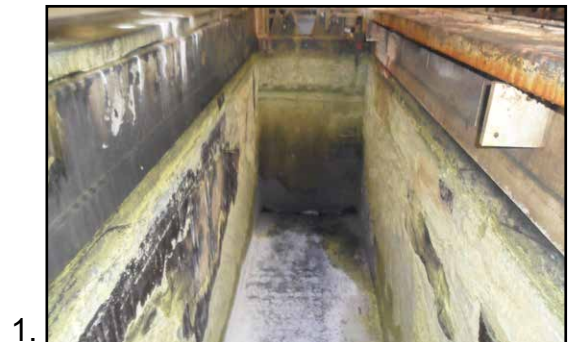
1. Tank location
2. Pre-start
3. Area preparation & pre-coated plate
4. Application completed

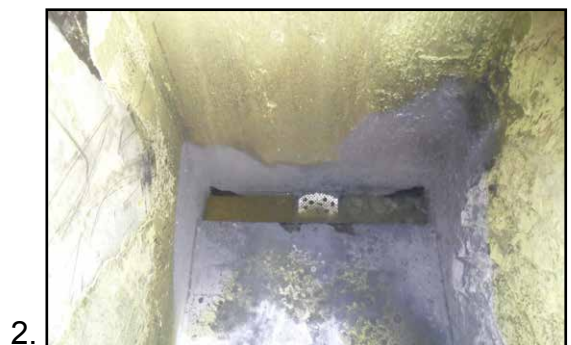
Corrosion issues prompted the Client to seek a cost effective solution to seal an internal-to-external drainage outlet. A swift application was required to eliminate any uncontrolled discharges of the acid to the internal working area.
