BELZONA CORROSION PROTECTION FOR SUCTION SCRUBBER

Oil and Gas Industry, North Sea, UK

Corrosion protection required for newly constructed process vessels.

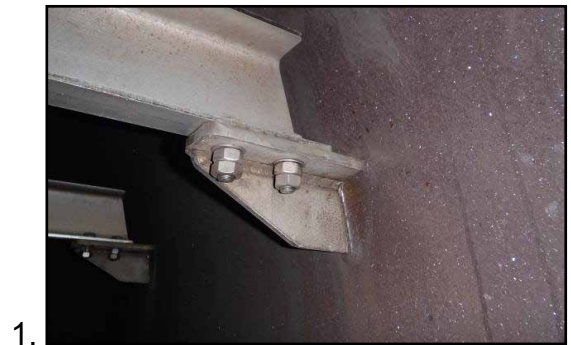
1. Inspection in 2013 - Inside view of the scrubber
2. Patch repair
3. Different view of patch repair
4. View around ladder

Belzona lining was specified to protect new process vessels and utility tanks. Based on Belzona track record since the 1990s, the customer opted for a carbon steel shell lined with Belzona rather than stainless steel cladding. During the 2013 inspection, it was reported that the Belzona lining was in excellent condition. Local repairs carried out during the initial application were still in very good condition with no sign of degradation.
