BELZONA REPAIRS TANK NOZZLE

400,000 sulfuric acid holding tank nozzle.

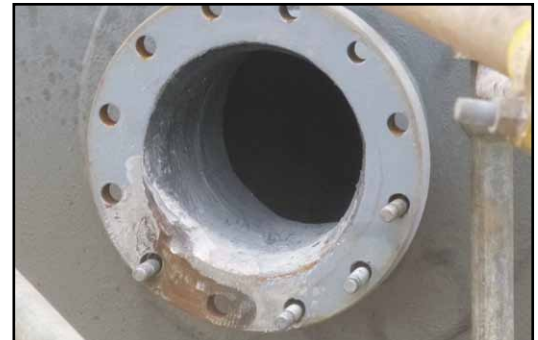
The original coating inside the tank nozzle failed due to acid erosion. Sulfuric acid began leaking into the containment area.

1. Damaged tank nozzle
2. Blast work being carried out on tank nozzle
3. Rebuilding the flange of the nozzle with Belzona 4301
4. Completed nozzle with Belzona 4311 coating
