PROVEN BELZONA REPAIR AND PROTECTION OF FLOOR PROBLEM AREAS

Correctional Facility, Missouri, USA

Metal tread on concrete steps

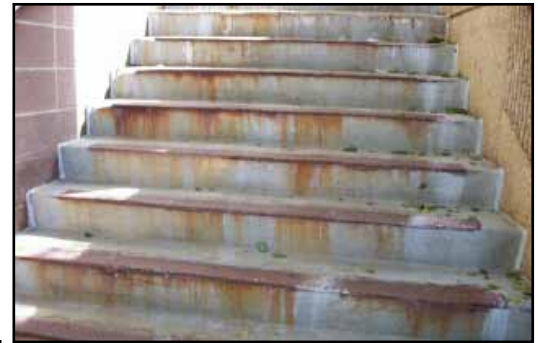
The metal treads on these stairs had come loose due to severe spalling around the fasteners. The corrosion of the treads had stained the risers and created an unsightly appearance. The conventional solution was a costly tear-out and replacement.

1. Overview damage of treads on concrete steps
2. Damage to the concrete
3. Completed application
4. Inspection after 12 years shows steps to be in perfect condition
