BELZONA TIRE REPAIR QUICKLY GETS LOADER BACK IN SERVICE

Repair of the tire sidewall on a front end loader.

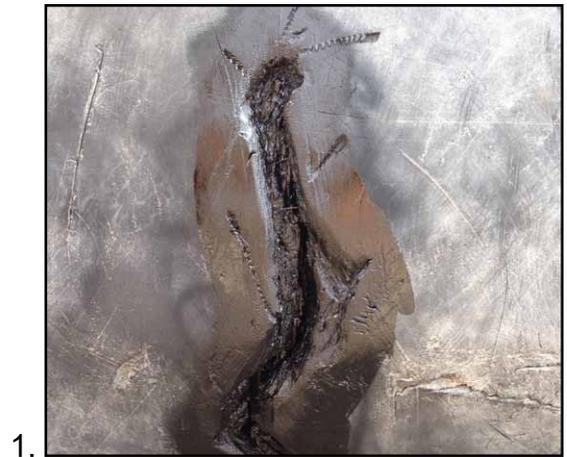
1. Crack cleaned, roughened, and conditioned.
2. Application of Belzona 2311.
3. Two weeks later, material which had exceeded the conditioned area had peeled and need to be trimmed off (always tape off your edges!).
4. Repair revisited 3 Months after application, Belzona still perfectly adhered.

The application was carried out in accordance with Belzona Know-How System Leaflet SHM-15. The area to be treated was cleaned with a cleaner/degreaser and then abraded using a wire wheel, Belzona roughing brush and rotary tool. After a final cleaning the area was treated with Belzona 2911 and allowed to dry for 30 minutes. Belzona 2311 was then used to coat the radials and rebuild the profile of the tire. The entire application was completed and the loader was back in service in less than two hours.
