## BELZONA KEEPS THE BELT MOVING

Production line conveyor belt in a steel foundry.

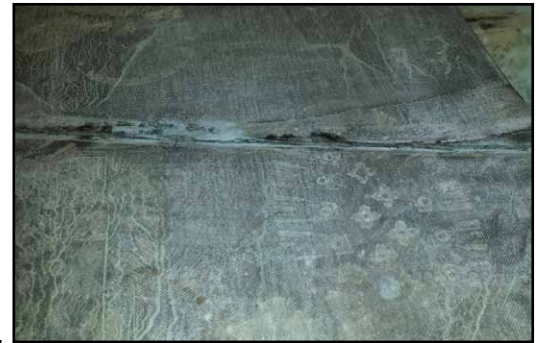
The edges of the conveyor belt were separated due to a failure on the bonding area.

1. Close-up view of the separating seam.
2. Surface prepared with the MBX Bristle Blaster.
3. Application of Belzona 2911.
4. Completed application.
