## BELZONA REPAIR EXTENDS SERVICE LIFE OF TIRE

Quarry, Tennessee, USA

September 2015

Large split in the tire (Half Track) sidewall.

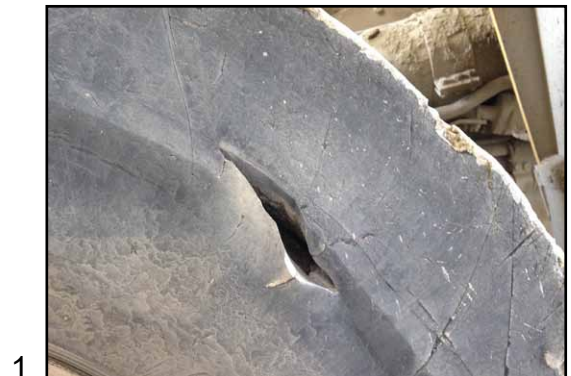
A large crack had developed in the tire sidewall, over 8 inches long and more than 3 inches deep in places. The "half-track" tire (outer half solid rubber/inner half inflated) was nearing the end of its service life and the customer had ordered a new one but had already been waiting for over two months. The site superintendent was very concerned that the crack would continue to grow and reach a point of being unsafe before new tires became available.

1. Large crack in tire
2. Crack being terminated, cleaned, roughened and conditioned
3. Application of Belzona 2311 in progress
4. Completed application
