RISER BOOT SEALED WITH BELZONA

Oil and Gas Industry, North Sea, Norway

July 2003

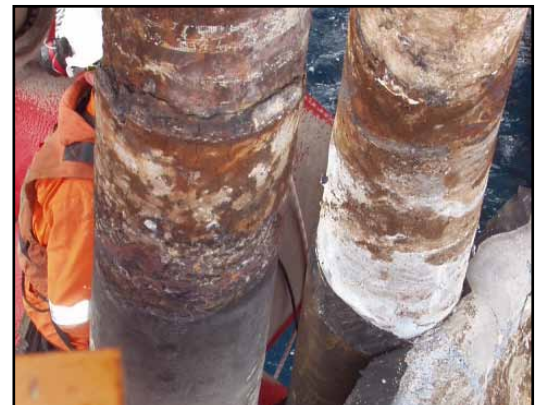
1. Removing the old neoprene
2. Applying the Belzona 2121 onto new neoprene
3. Completed application
4. Inspection in 2010

The customer was concerned that after replacing damaged neoprene, water would penetrate between the riser and the cladding onto glassflake coating and cause disbondment.

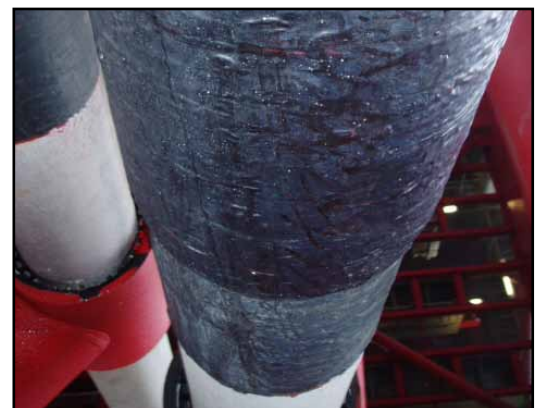
4.

Belzona was chosen due to its high adhesion to both neoprene and glassflake. Another advantage for the applicators was the relative ease of application of the Belzona products. As of February 2015 the application is still in perfect condition.
