BELZONA PROTECTS NEW STAINLESS STEEL PIPE SPOOLS

Gas Fired Power Station, Avonmouth, UK

December 2014

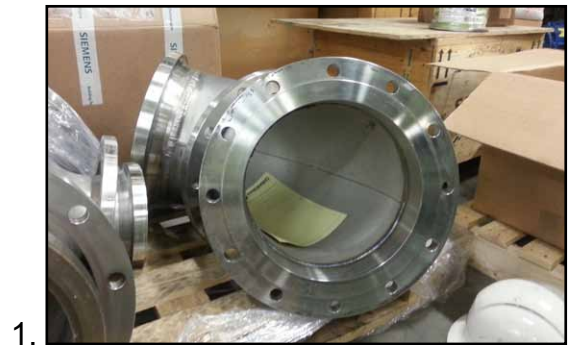
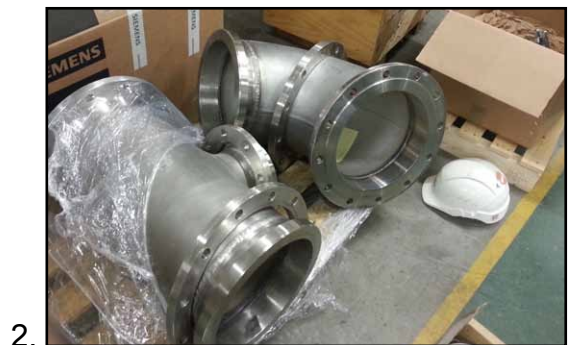
1. New pipe spools before coating
2. New pipe spools before coating
3. Pipe spools after coating
4. Pipe spools after coating

The application was carried out in accordance with Belzona Know-How System Leaflet VPF-2. After masking off all areas not to be coated, all edges were radiused and welds ground smooth before being grit blasted and coated with the Belzona 4311 system.
