BELZONA REPLACES PTFE LINING AND CUTS DOWNTIME

Chemical Plant, Ferrara, Italy

Reactor operating between 70°C and 80°C at a Polyolefins petrochemical plant. Process fluids included salt, caustic and titanium tetrachloride.

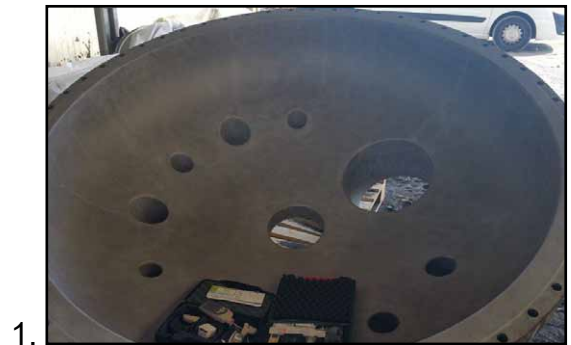
1. PTFE lining removed
2. Belzona lining applied
3. Coating thickness measured
4. Inspected after 6 months in service

The application was carried out in accordance with Belzona Know-How System Leaflet TCC-5 for protecting and rebuilding steelwork. After grit blasting to SA 2.5, a two-coat system of Belzona 1593 was hand applied to an area of 25 m².
