BELZONA REPAIRS RUBBER PRESS ROLL

Rubber press roll used to laminate gasket sheets together.

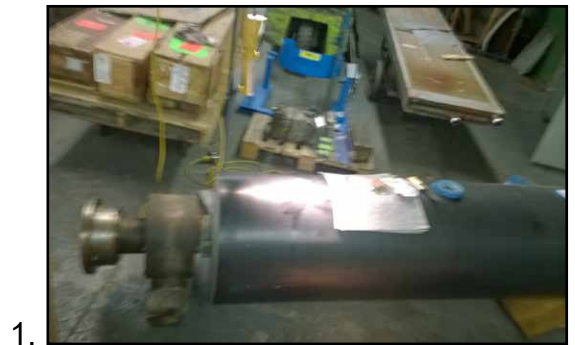
1. Rubber press roll
2. Deep hole in press roll
3. Cleaned, prepped and masked off hole to be repaired
4. Repaired hole and used a razor blade to cut and smooth final surface

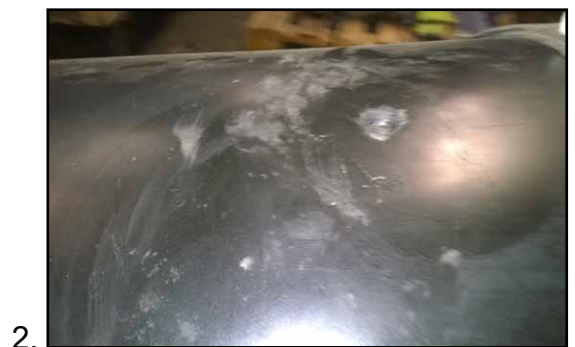
Rubber press roll had a hole caused by a tool impact, which made the roll unusable and not being able to create a smooth gasket.
