## BELZONA SEALS ASH TANK ROOF

Power plant, Guangxi, China

Roof of ash tanks in the power plant

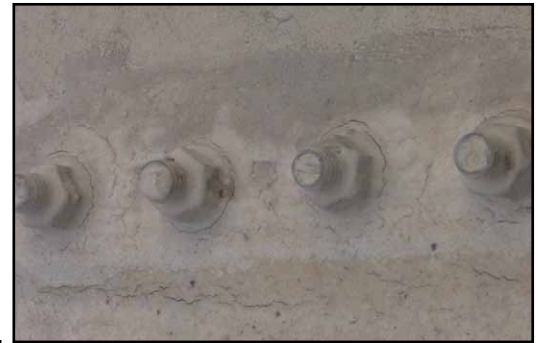
After years of service, the steel plates had started leaking. Two other coatings were applied but both failed.

1. The previous coating failed within 1 year. The cracks in the joint caused leaking
2. The repair work was completed with Belzona solution
3. Overview of the completed application
4. After 7 years, the repair still in perfect condition

Application was carried out in accordance with Belzona Know-How System Leaflet FPA-6, RPA-1 and 6. The joints were sealed with Belzona 2211, before applying a fully reinforced Belzona 3111 Flexible Membrane system.

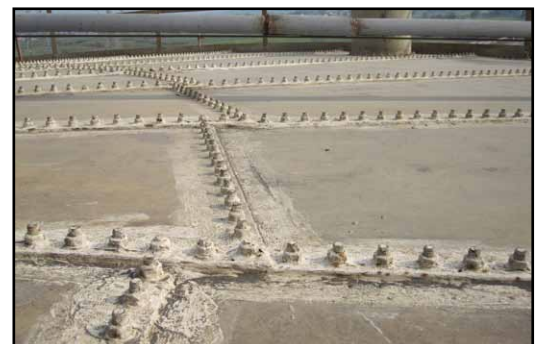
4.

Belzona solution for tank roof offers longer service than the conventional welding. The performance is far superior than other coatings the client tried. This cost effective solution won client's trust. After 7 years in service, the repair work is still in perfect condition and the client is looking to have more roofs repaired by Belzona.
