FLEXIBLE PROTECTION FOR ACID BUND WITH BELZONA

Power Plant, Missouri, USA

Chemical Bund around 93% Sulfuric Acid Tank

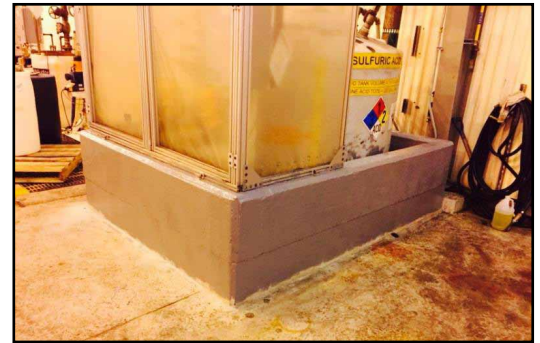
The bund in place to contain spillages from a 93% sulfuric acid tank experienced splashes and spills, resulting in the failure of existing protection. In addition, structural movement resulted in small gaps forming between the floor and bottom of the wall inside the containment area.

1. Chemical Bund containing 93% Sulfuric Acid Tank
2. Belzona 4361 applied in two coats
3. Completed application
