## BELZONA MADE A QUICK AND EASY BELT REPAIR

The conveyor belt that is carrying dry waste at the Waste Water Treatment Plant.

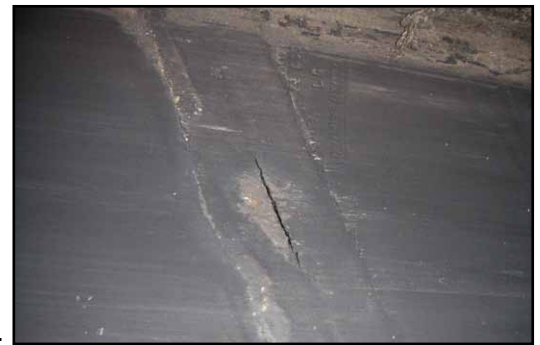
A tear in a conveyor belt carrying solid waste threatened to shut down this section of the plant. The belt has previously been repaired by hot vulcanizing, which did not provide a long term solution.

1. Tear in belt.
2. Surface preparation.
3. Application of Belzona 2311.
4. Completed application.
