BELZONA REBUILDS ERODED FLANGE FACE

APPLICATION SITUATION
Eroded flange face

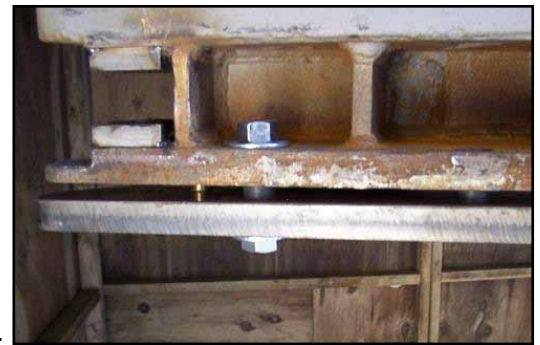
1. Close up of flange showing spacers glued in place to take up the required gap.
2. The flange former was systematically tightened, squeezing out the excess material which was wiped away before it hardened.
3. Application completed.
4. Sonar dome in place.
