BELZONA PLATE BONDING SOLUTION SEALS STEEL PLANT GAS LEAKS

Steel Plant, Sweden

October 2015

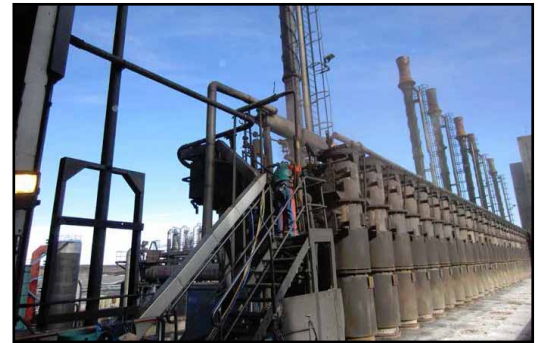
Significant number of gas leaks around the coke ovens threatened fines and closure of the plant from the environmental authorities.

1. View of steel plant furnaces with corrosion problems
2. Heavily corroded base underneath the debris
3. Applying Belzona 1251 to prepared area
4. Completed application after coating with Belzona 5851
