## MORE THAN 500 FLANGES ENCAPSULATED WITH BELZONA

Gas Supplier, Oman

Flange connections on a gas distribution station

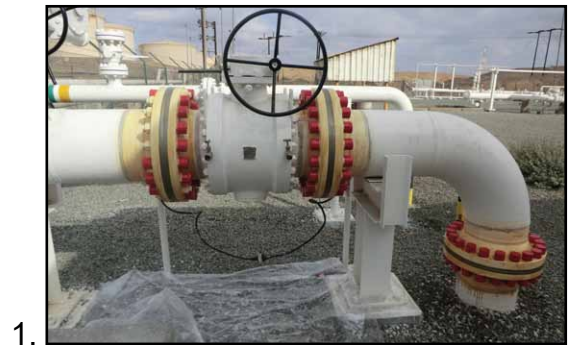
1. Substrate ready for application with bolt covers, bridging tape and application of Belzona 8411
2. Application of base coat of Belzona 3411
3. Application completed with second coat of Belzona 3411
4. Completed applications on several flanges
