RECOVERY AND PROTECTION OF OLD HEAT EXCHANGER WITH BELZONA

Oil Refinery, Bulgaria

Old heat exchanger in oil refinery cooling benzene fractions with hydrogen sulfide at working temperature up to 70°C.

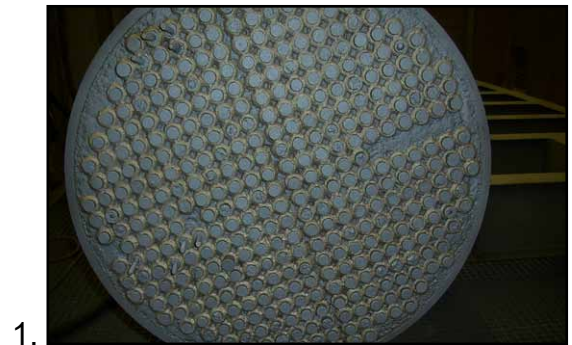
1. Grid blasted plate
2. Formers and cork plugs used to limit the repair area
3. Corroded areas rebuilt with Belzona
4. Application completed after 2 coats of Belzona 1391T and cork plugs pulled out

The application was carried out in accordance with Belzona Know-How System Leaflets HEX-1 and HEX-3. After grit blasting, erosion damage was rebuilt before applying Belzona 1391T for overall corrosion protection. A special flange shaped former was coated with Belzona 9411 and positioned so the flange remained uncoated.
