BELZONA REPAIRED CAR PARK JOINT STILL INTACT

Shopping Centre, Brisbane, Australia

The floor joint between concrete slabs in a car park.

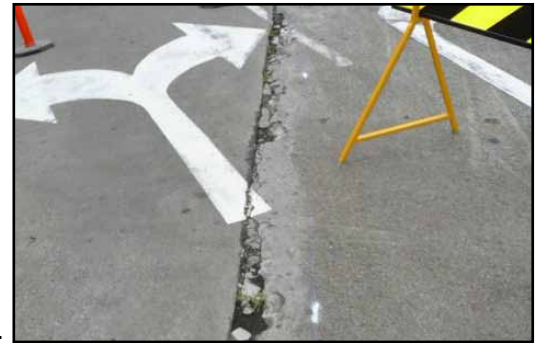
The edge nosings of the concrete slabs had been broken down to rubble after years of daily traffic making them unsightly and dangerous

1. The damaged floor joint
2. Conditioned and ready for repair
3. Repairs in progress
4. Repaired joint 3 years after completion

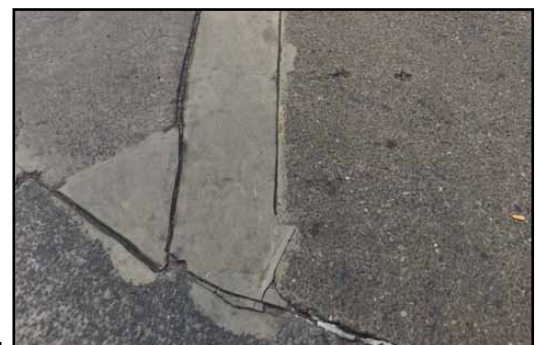
4.

Belzona 4111 was used for its high strength, fast curing and ease of application. The floor repair is still in good condition more than 3 years later.
