BELZONA KEEPS HISTORY MOVING

Shimming of Mounting Plates

A carriage company operated the last steam driven bus in the world. "Elizabeth" is a 1931 Sentinel DG6P steam bus, which has been offering charabanc rides around the streets of Whitby since 2005. The steam engine generates a huge amount of vibration which accelerates the rate of wear on all engine parts. In this case, the aluminium face of cast mounting plates had been heavily damaged by the vibration of the cast iron sections of the engine.

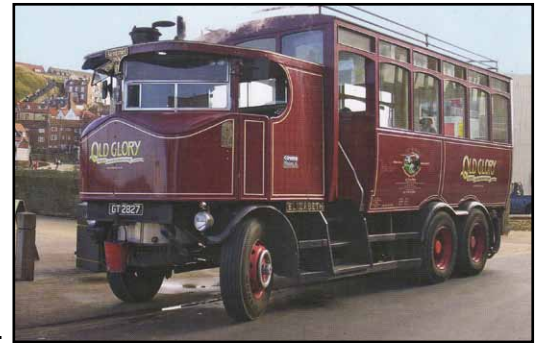
1. Sentinel Steam Bus "Elizabeth" recently refurbished
2. "Elizabeth" taking tourists around Whitby
3. Right hand side mounting plates refitted
