## BELZONA SAVES THE ALIGNMENT OF THE PUMP AND MOTOR

Deer Park, TX, USA

February 2016

Metal Pump Base

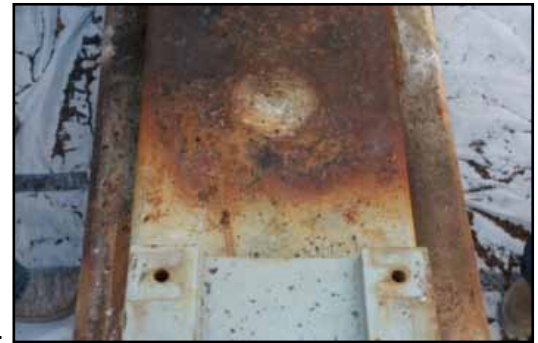
The occasional leaking seal of process water was causing the advanced corrosion attack of the metal substrate of the pump base, which was leading up to the possibility of the base collapsing. At which point the pump and motor would be out of alignment.

1. Corroded pump base.
2. Pump base blasted and Belzona 1121 being applied.
3. Belzona 5811 applied to pump base.
4. Belzona 5233 applied as a top coat.
