BELZONA STATIC DISSIPATIVE SOLUTION APPLIED TO SILO

Bio-fuel Producer, Mannheim, Germany

November 2011 - February 2012

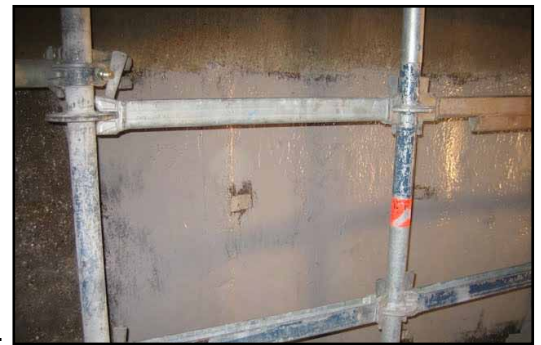
1. Earthing points left exposed in restored silo wall
2. Section of silo coated in Belzona 4351
3. Silo cone repaired and left with earthing points
4. Silo cone coated with Belzona 4351

Application was carried out in accordance with Belzona Know-How System Leaflets TCC-3. Damaged concrete was repaired with Belzona 4111. Belzona 4351 was applied to walls and cone taking care to ensure Belzona 4351 was in direct contact with the earthing points provided.
