BELZONA REPAIRS DOME ROOF

Mosque, Woking, UK

September 2016

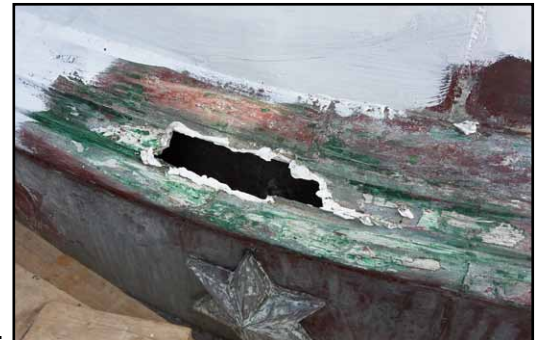
The dome was showing signs of ageing and there were a large number of holes around its circumference.

1. Extent of the damage
2. Damaged zinc dome rebuilt with Belzona 1121
3. Belzona 3111 applied
4. Completed application prior to the removal of the scaffolding
