BELZONA REPAIRS DEFECTS ON HYDRAULIC RAMS

Hydroelectric Plant, Bulgaria

280mm diameter x 3500 mm long hydraulic rams used to operate main dam outlets.

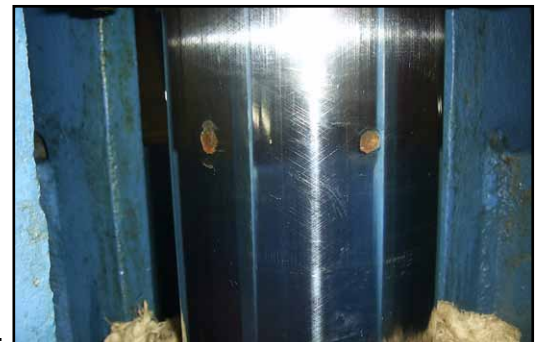
Ongoing corrosion of point defects in the stainless cladding on the rams had led to the large defects now seen. Sharp edges on the defects could cause damage and rupture of the rubber seals. Repair area was only accessible through a 450x300mm window at the bottom of the hydraulic device.

1. Defects in one of the rams
2. Preparation completed
3. Masking defects
4. Completed application
