BELZONA GIVES NEW LIFE TO ALMOST SCRAPPED PUMPS

Copper Processing Plant, Bulgaria

Split casing pumps type 500LNN1000 used for water recycling in copper ore processing.

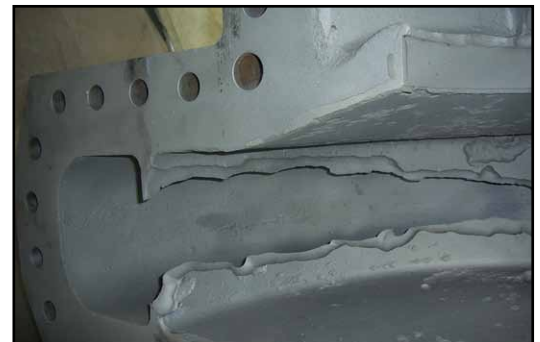
Due to many years of service exposed to erosion and corrosion effects, the housings and covers of two pumps had significant wear, particularly at cutwaters, flow straighteners and wear ring seats. The pumps had been decommissioned and considered as scrap before the Distributor proposal for recovery with products and technologies of Belzona.

1. After blasting the pumps' wear clearly visible
2. Reinforcing framework to cutwater
3. Rebuilding with Belzona 1311
4. Completed application with two coats of Belzona 1341

The application was carried out in accordance with Belzona Know-How System Leaflets CEP-1, CEP-2 and CEP-3. The pump surface was prepared by blasting, severe damages and missed edges required reinforcing the steel framework with the application of Belzona 1311 to restore original profile. Forming technique was used for wear ring seats and gland housings. After whole case and cover recovery and flash blasting, two coats of Belzona 1341 were applied.
