BELZONA WITHSTANDS PROLONGED WET ABRASION

Paper Mill, Turin, Italy

Sludge immersion pump at a paper mill operating under severe wet abrasion conditions.

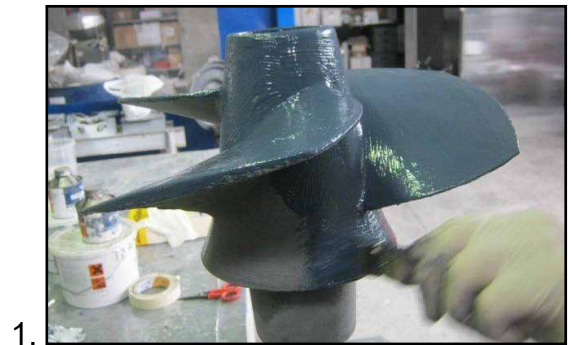
1. Pump impeller being coated
2. Pump lining applied
3. External coating applied
4. Inspection after 4 years in service

The application was carried out in accordance with Belzona Know-How System Leaflets CEP-3, CEP-4 and CEP-5. Surface preparation was carried out using grit blasting. Pitted and eroded areas were rebuilt with Belzona 1311, the internal surfaces were then coated with Belzona 1321 to protect the pump from erosion-corrosion. Belzona 5811 was then used to protect the external surfaces of the pump.

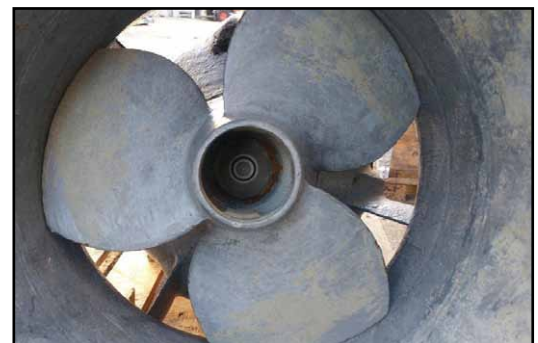
4.

The Belzona solution successfully withstood wet abrasion and managed to significantly prolong the life of this pump. After 4 years in service, the pump was inspected and found to be in perfect condition, with the Belzona coatings predominantly intact. These 4 years of stress-free operation amounted to significant savings due to the absence of maintenance and downtime. The length of maintenance-free time has now been doubled and instead of scrapping the whole pump, customer only needs to replace the coating.
