END COVER OF CONDENSER RECEIVES BELZONA HT SOLUTION

Gas Plant, Southeast China

End cover of condenser. Design temperature: 130°C; design pressure 0.1MPa

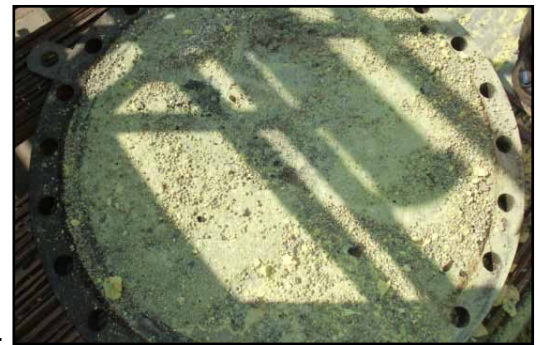
Severe pitting corrosion appeared on the cover after years of operation. The worst pitting is about 10mm deep.

1. The internal surface before application
2. Severe pitting damage
3. Completed application
4. The coating after 4 years shows no sign of further corrosion

Application was carried out in accordance with Belzona Know-How System Leaflet HEX-3. Belzona 1511 was used to rebuild the profile followed by an application of Belzona 1591 as a high temperature protective coating.

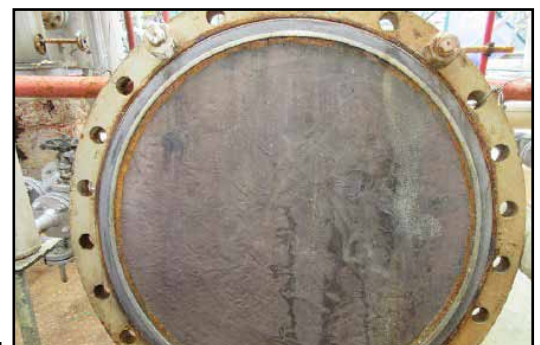
4.

The cover was originally unlined. Belzona's solution prevented the cover from further corrosion, extended the equipment life and eliminated the cost of replacement. After 4 years in service, the coating is in perfect condition.
