BELZONA PROVIDES EMERGENCY REPAIR ON A WORN CONVEYOR BELT

Worn conveyor belt

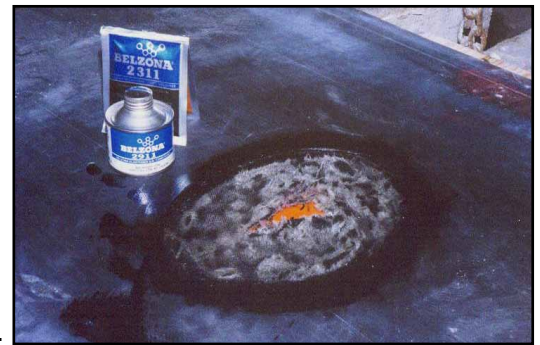
A large hole had formed in this conveyor belt, causing an interruption in production.

1. Damaged conveyor belt, ready for repair.
2. Close up of repair area showing the use of the Belzona mixing surface, which was positioned underneath the belt to act as a suitable temporary backing for the repair.
3. Completed application.
