TRAIN BAGGAGE CAR SEALED AND PROTECTED WITH BELZONA

Railroad Company, Montana, USA

2004

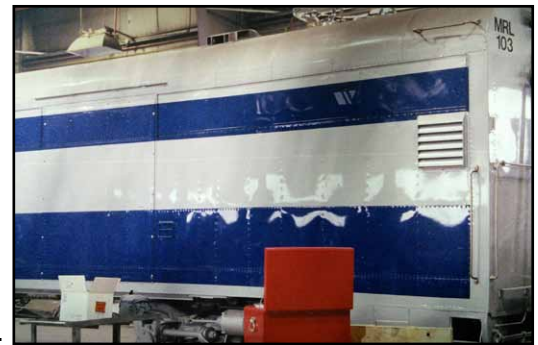
The car of a private passenger train, which housed an electrical generator and a baggage section. The interior was beautifully finished with carpet and paintings. The leak in a seam could cause extensive water damage to the interior of the car.

1. Generator/Baggage car in a car shop
2. Surface preparation underway
3. Full length of joint being applied
4. Finished joint looks very aesthetic

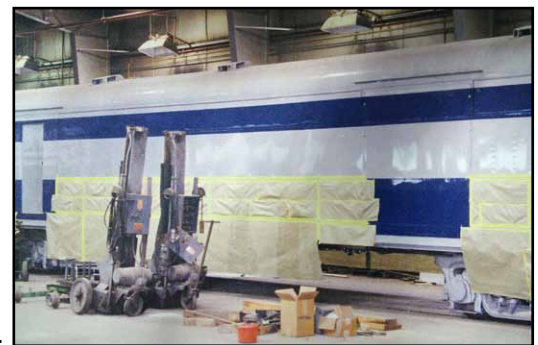
3.

Leaks on a riveted/stitch-welded seam. Since the car had already been painted and finished on the exterior, a cold process needed to be used to save the decorative paint. Also, the car needed a flexible seal to accommodate the movement while traveling. With the expense already invested, a long term solution needed to be found that would stay flexible and withstand the elements in extreme weather.

Belzona 2211 allowed the applicators to install the material without damage to the finished surfaces inside and outside of the wall. Belzona 2211 is a paste grade material for rebuilding up to 0.5 in thickness without slump, allowing the application to be performed on a vertical wall without forming techniques. Belzona 2211 is also a long term solution that will hold up to the outdoor conditions and weather, preventing damage later as well as numerous re-applications.
