TOUGH AND LASTING BELZONA PROTECTION FOR PUMP IN DESULFURIZATION UNIT

Power Plant, La Spezia, Italy

Rubber coated pump cone in a desulfurization unit at a fossil power plant.

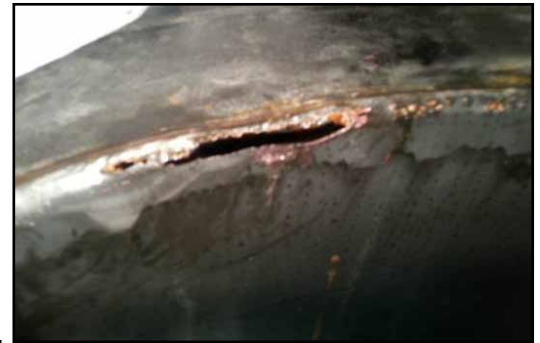
The cone was suffering from severe dry abrasion in the presence of strong concentrations of sulfides. Previously applied rubber coating started to peel, leading to leakages between flange couplings. Leaking corrosive substance in turn attacked the underlying metallic substrate, thus reducing the efficiency and the working life of this component.

1. Original holed rubber lining
2. Application of Belzona 1811
3. Application of Belzona 1811
4. Inspection after 1 year in service

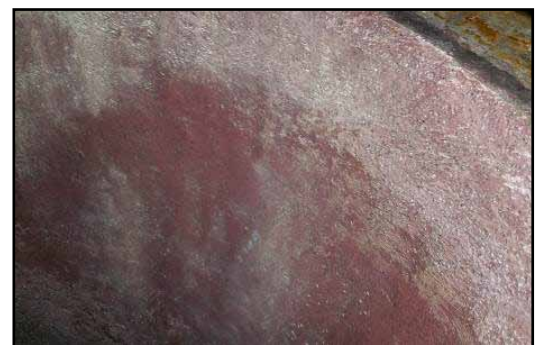
4.

This Belzona solution succeeded where a competitive system had failed. After a year in service, Belzona 1811 is still in a as new condition, to the customer's delight. The Belzona solution effectively enhanced efficiency and the working life of this component.
