## BELZONA REPAIRS AND PROTECTS HEAT EXCHANGER

Chemical plant, Croatia

March 2011

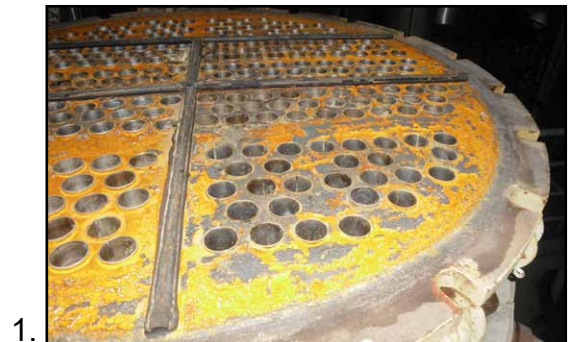
Severe corrosion/erosion on both ends of two heat exchangers,

1. Problem close up
2. Blasted surface
3. Repaired surface
4. After 3 years in service

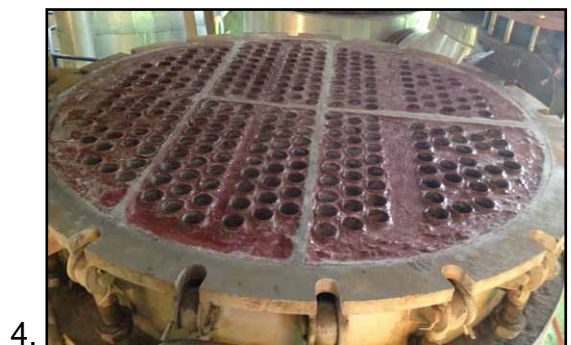
The customer was in the process of sourcing quotes for a new heat exchanger. Belzona offered a lower cost alternative with minimal delay and disruption to production. Belzona has provided excellent protection.
