## SEA WATER PUMP REPAIRED AND PROTECTED WITH BELZONA

Power Plant, Venice, Italy

Casing and components of the sea water circulation pump.

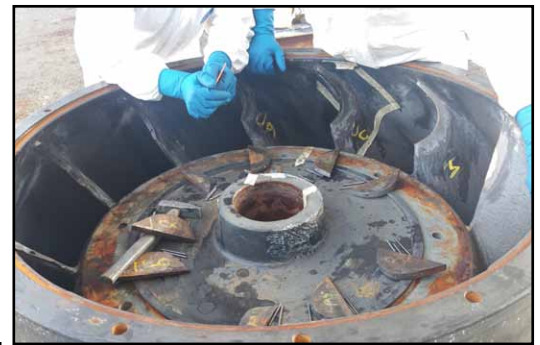
After several years in service, the surfaces had become corroded and eroded by sea water. In addition, cavitation damage on the vanes of the diffuser was seen as a major problem.

1. Evident damage to the vanes
2. Casing lined and coated
3. Vanes repaired and edges protected with Belzona 2141
4. Completed application to pump components

The application was carried out in accordance with Belzona Know-How-System Leaflets CEP-1, CEP-3, CEP-4 and CEP-10. Damaged vanes were removed and reinstalled with mechanical metal stitching repair techniques. The surface was then coated with Belzona 1341. The edges of the diffuser blades were protected from further cavitation damage with Belzona 2141.
