BELZONA STOPS COSTS SPIRALLING OUT OF CONTROL

Pigment Manufacturer, UK

Spiral Heat Exchangers commonly used within part of the client's facilities.

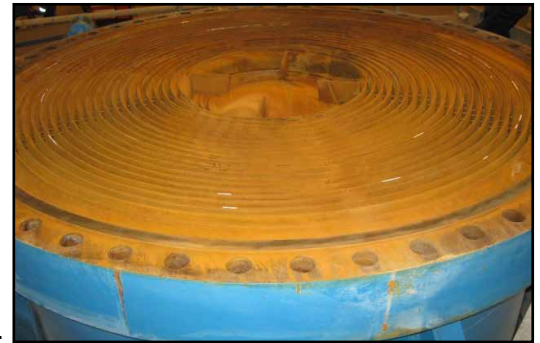
An unwanted reaction within these assets is the formation of hot hydrochloric acid, which was then attacking the steel spirals. It was thought that there were only a few weeks left before the heat exchanger would fail. The lead time on a replacement was nearly 12 months.

1. One end of spiral heat exchanger untreated
2. Belzona 4311 application underway
3. Close up of coating
4. Completed application
