## BELZONA REPAIRS CONCRETE ROAD IN CHEMICAL PLANT

Chemical Plant, Teesside, UK

Concrete damage on plant roads.

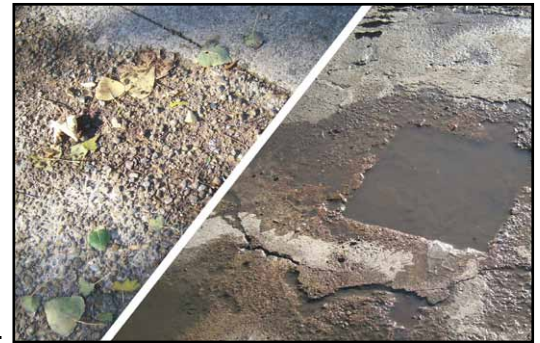
The roads on site had suffered attack from chemicals and regular heavy lorry traffic had cracked and eroded the concrete in many areas around the plant, including access roads. Repairs had been completed several times previously with cementitious materials. These had, however, never survived for long and once again the uneven surfaces had become hazardous for vehicles and foot traffic alike.

1. Typical damage on roads around site
2. Cracks filled and area resurfaced
3. Further repairs completed in main road
4. Repair revisited after 5 years

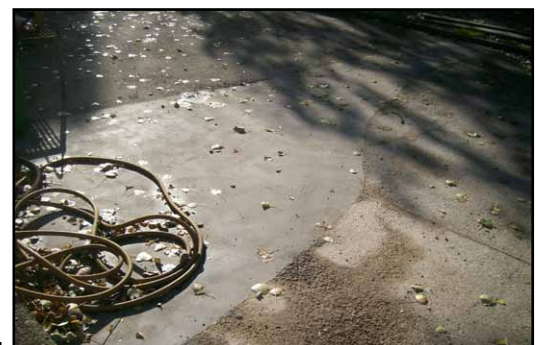
4.

The Belzona solvent free concrete repairs offered a long lasting solution with a proven track record. Due to the extent of repairs required, Belzona 4131 was chosen as the most cost effective solution. For deep damage, Belzona 4131 was bulk filled 50/50 with 6mm pea gravel and resin before topping with Belzona 4131. The repairs were revisited after 5 years and there was only minor cracking in the heaviest traffic areas where it was known that there were still loose slabs.
