BELZONA REFORMS SEAL FACES IN SHIPS CYLINDER BLOCK

Naval Ship Repair Yard, Bulgaria

Seal faces for cylinder liners of diesel generator. Repairs required whilst ship was in drydock.

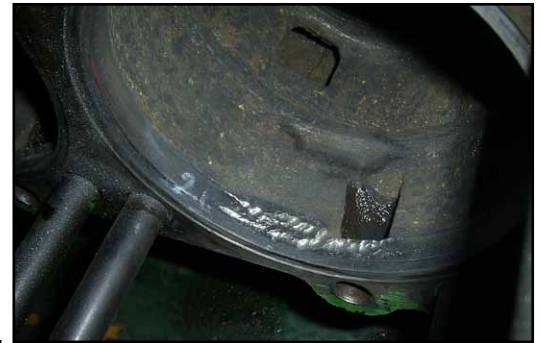
Erosion and corrosion had damaged the seal faces. Conventional repairs were not an option.

1. Preparation of one defect completed
2. Forming plates coated with Belzona 9411
3. Application of Belzona 1111 in progress
4. Completed application

The application was carried out in accordance with Belzona Know-How System Leaflet ENC-5. After preparing the damaged areas, carefully profiled formers coated with Belzona 9411 were used to reform Belzona 1111 to the required seal face dimensions. Once cured, the formers were removed and excess Belzona was trimmed away to leave the accurately formed seal faces.
