BELZONA SEALS FLANGE ON VACUUM DRYER

Food Process, Girvan, Scotland

A large diameter (approximately 2m) flange on vacuum drying vessel.

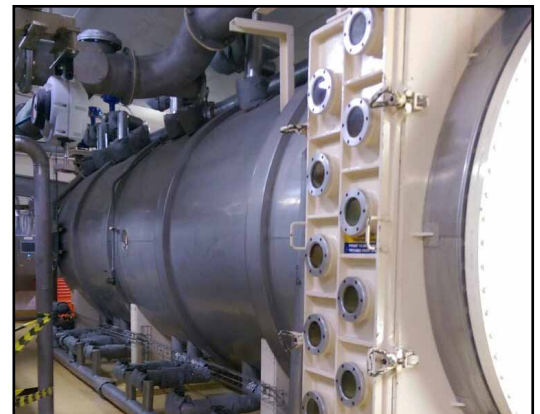
1. Vacuum vessel
2. 1st coat of Belzona 5851 applied with Belzona 9341
3. Application in progress
4. Completed flange seal
